Corrosion Analysis on Internal Plastic Coating Drill Pipe 5 Inch 19.50 PPF Grade G-105

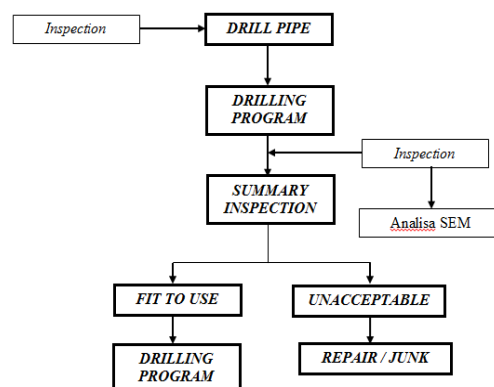
Figure 2. Research Flowchart

The research flow diagram of this research can be described in Figure 2.

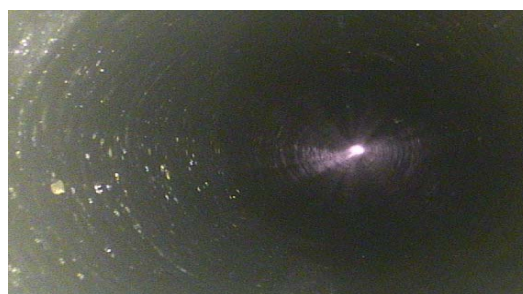
Internal Plastic Coating Condition 1

To inhibit corrosion of the internal parts of the drill pipe, the drill pipe has been coated with plastic coating, however, from the analysis and inspection reports, it was found that corrosion was quite significant in some drill pipes. The storage of the drill pipe in an open space and exposed to the sun allows the internal plastic coating to peel off so that it cannot completely protect the inside of the drill pipe. The pressure of the drilling mud when the user can erode the internal plastic coating itself, causing corrosion to the parts in the drill pipe. To find out the actual condition of the plastic coating, the Automatic Drift With Internal Cam prototype was used. In Figure 3 below is a comparison result of the internal plastic coating conditions using the DS-1 Volume 3 reference. Figure 1 is the condition of the internal plastic coating without any damage. Figure 2 is the condition of the internal plastic coating which is damaged by 30% of the total length of the pipe or from the surface area of the drill pipe. Figure 3 is the condition of the internal plastic coating which is damaged by 30% to 50% of the total length of the pipe or from the surface area of the drill pipe. Meanwhile, Figure 4 is the condition of the internal plastic coating which is damaged more than 50% of the total length of the pipe or from the surface area of the drill pipe.
